# UNDERWATER PIT EXCAVATION

# LAKE MEAD INTAKE No 3

**VOLUME I: DESIGN AND CONSTRUCTION  
OF THE UNDERWATER INTAKE STRUCTURE**

**Vegas Tunnel  
Constructors**

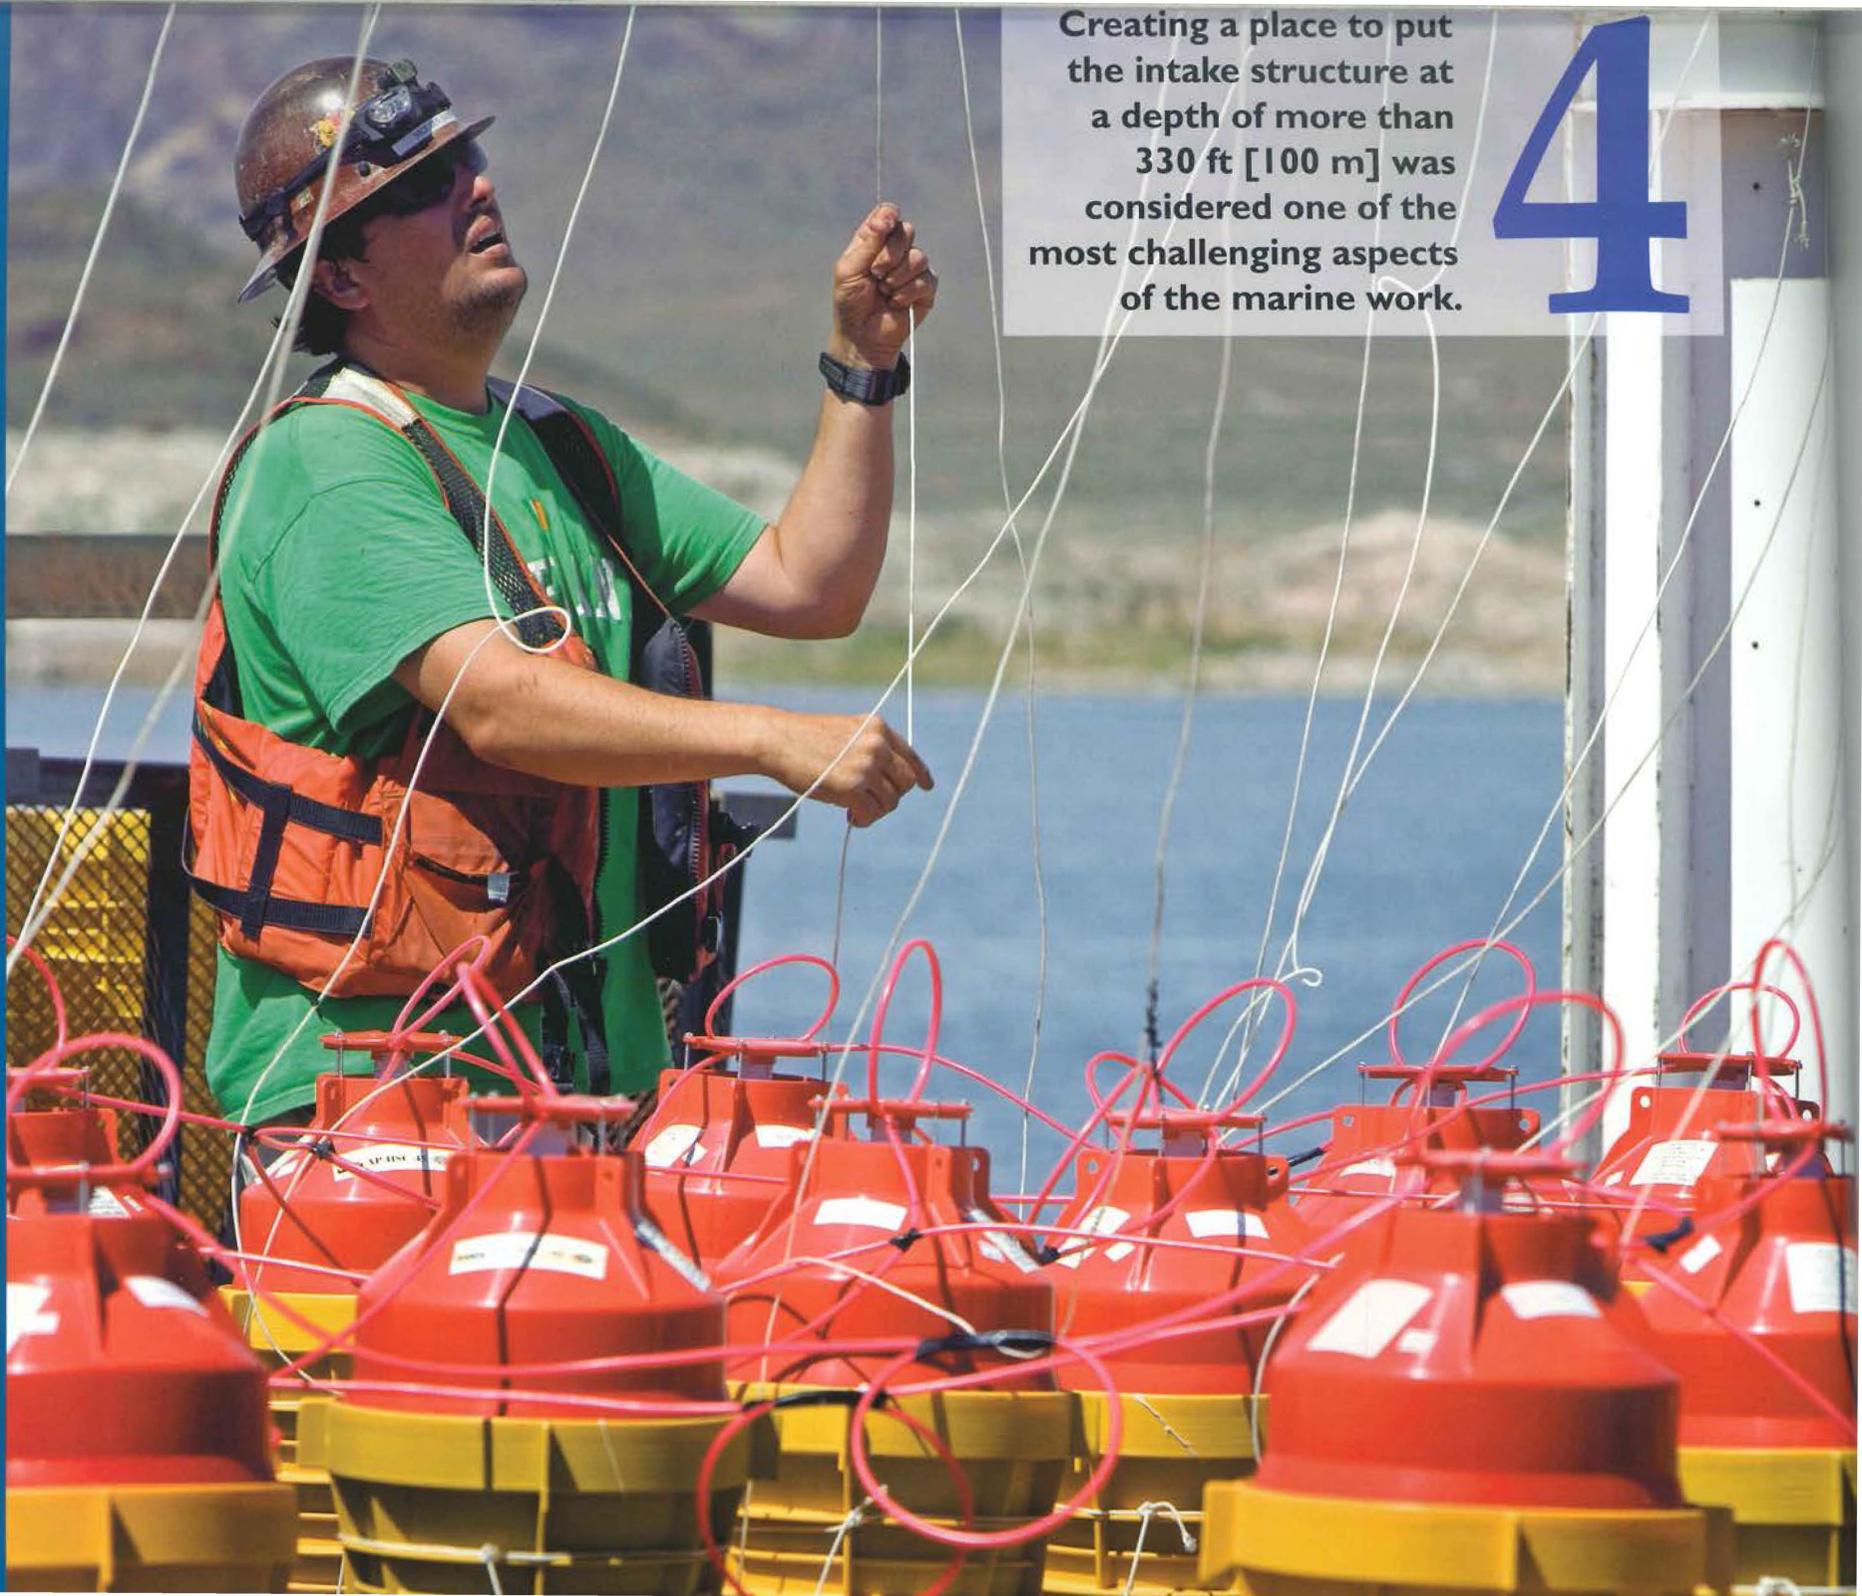
FIGURE 4.1 (PAGE 50) Functioning like mini-cannons, shaped charges are prepared for placement and detonation at the excavation site.

Shaped charges operate like a directed projectile: An explosive substance is positioned above an aluminum shell that is attached to a spacer, providing an adequate distance from the rock surface. The space between the rock surface and charge is designed to allow development of a slug created by rapid melting of the aluminum plate when the charge is detonated. The slug impacts the rock at high velocity, creating a crater or fracturing the rock (Folchi 2010). In many ways, this was a primitive approach to rock breaking, but since using explosives is a common tool in rock excavation, only a

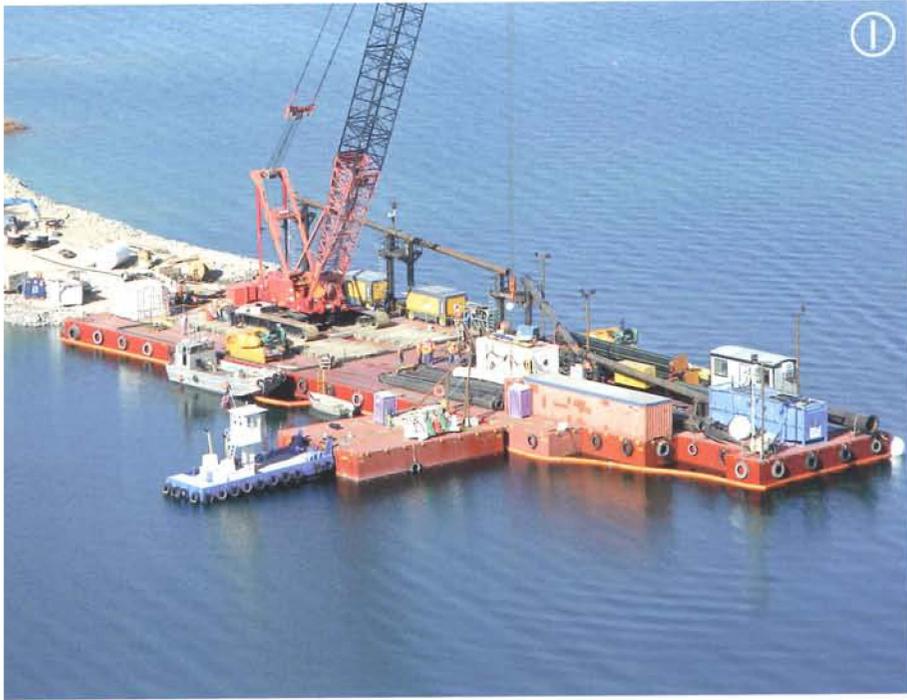
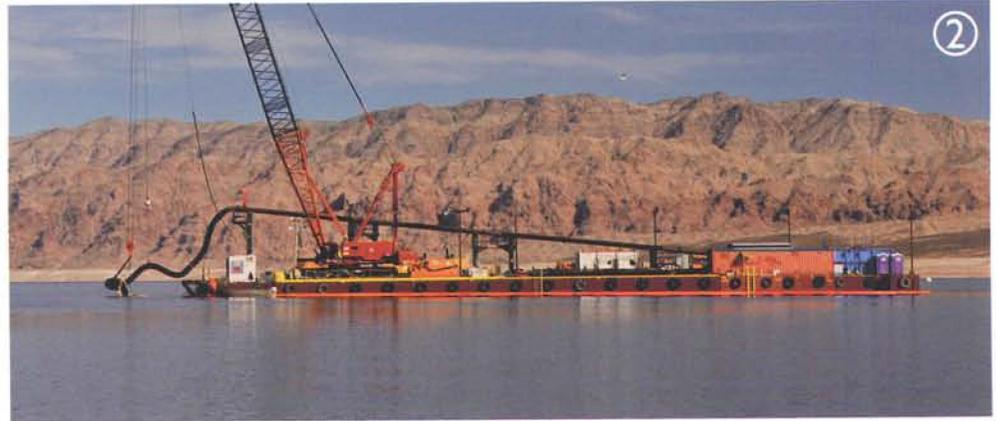
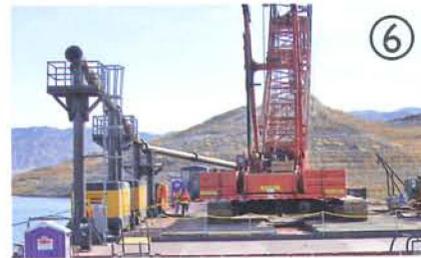
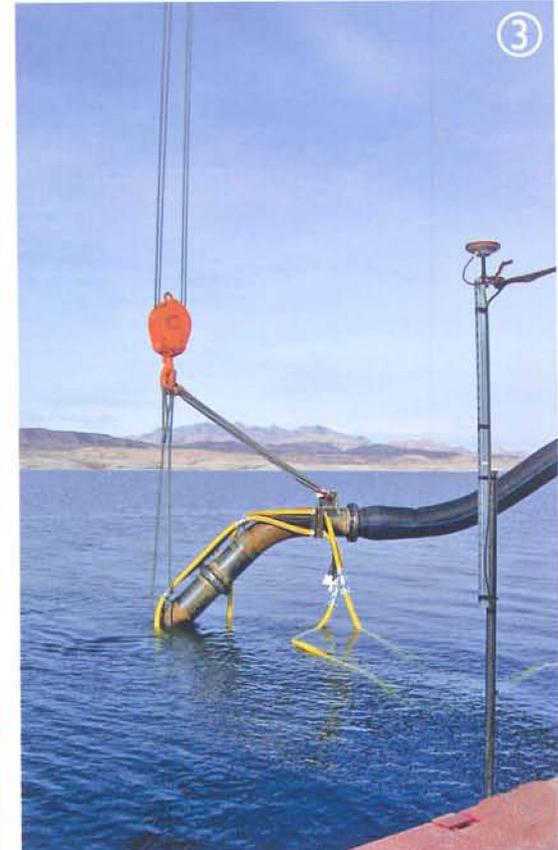
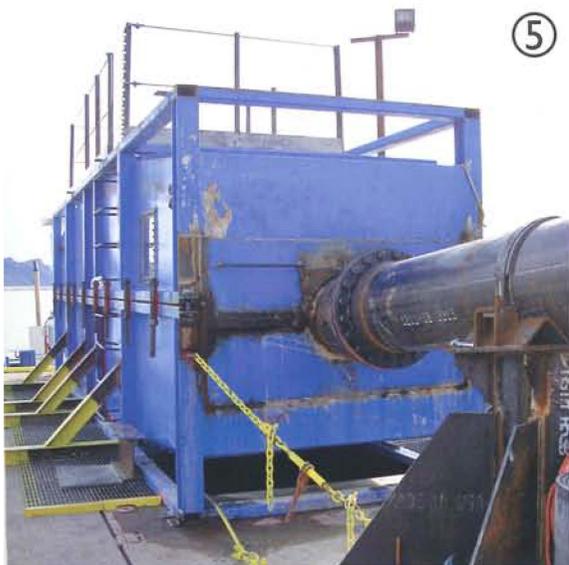
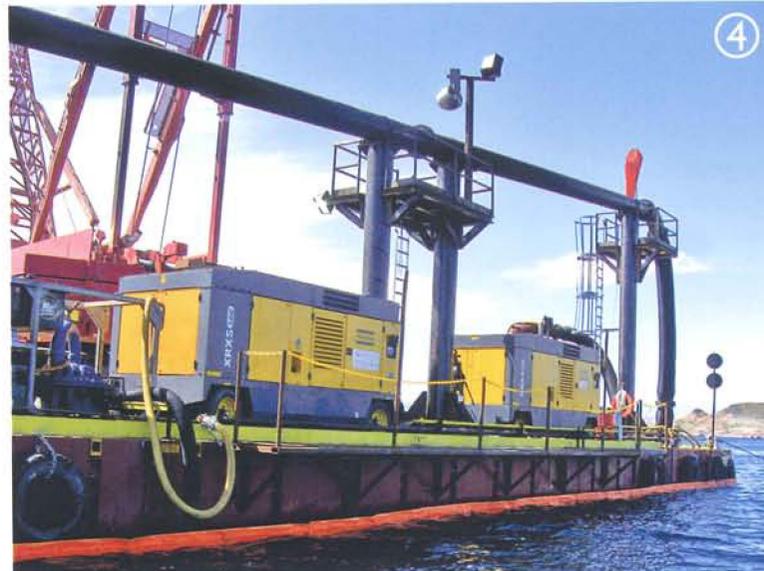
FIGURE 4.4 (PAGE 53) The crane barge configured for airlifting. ① Being outfitted at the staging area. ② In use. ③ A flexible pipe allowed manipulation of the suction side by crane. ④ Air compressors with airlift line above. ⑤ Hopper used to hold excavated material. ⑥ Airlift pipe and crane.

The overburden was to be excavated with an airlift system, complemented by the use of a crane with a clamshell bucket. The airlift system, successfully used by Impregilo-Healy on another project, was designed by VTC with the assistance of underwater specialist Mr. Rik Pellegrims of Rijmenam, Belgium. Two Atlas Copco air compressors supplied air to a 20 in. [500 mm] diameter pipe to perform the airlift excavation. See Figure 4.4 for photos of the airlift assembly.

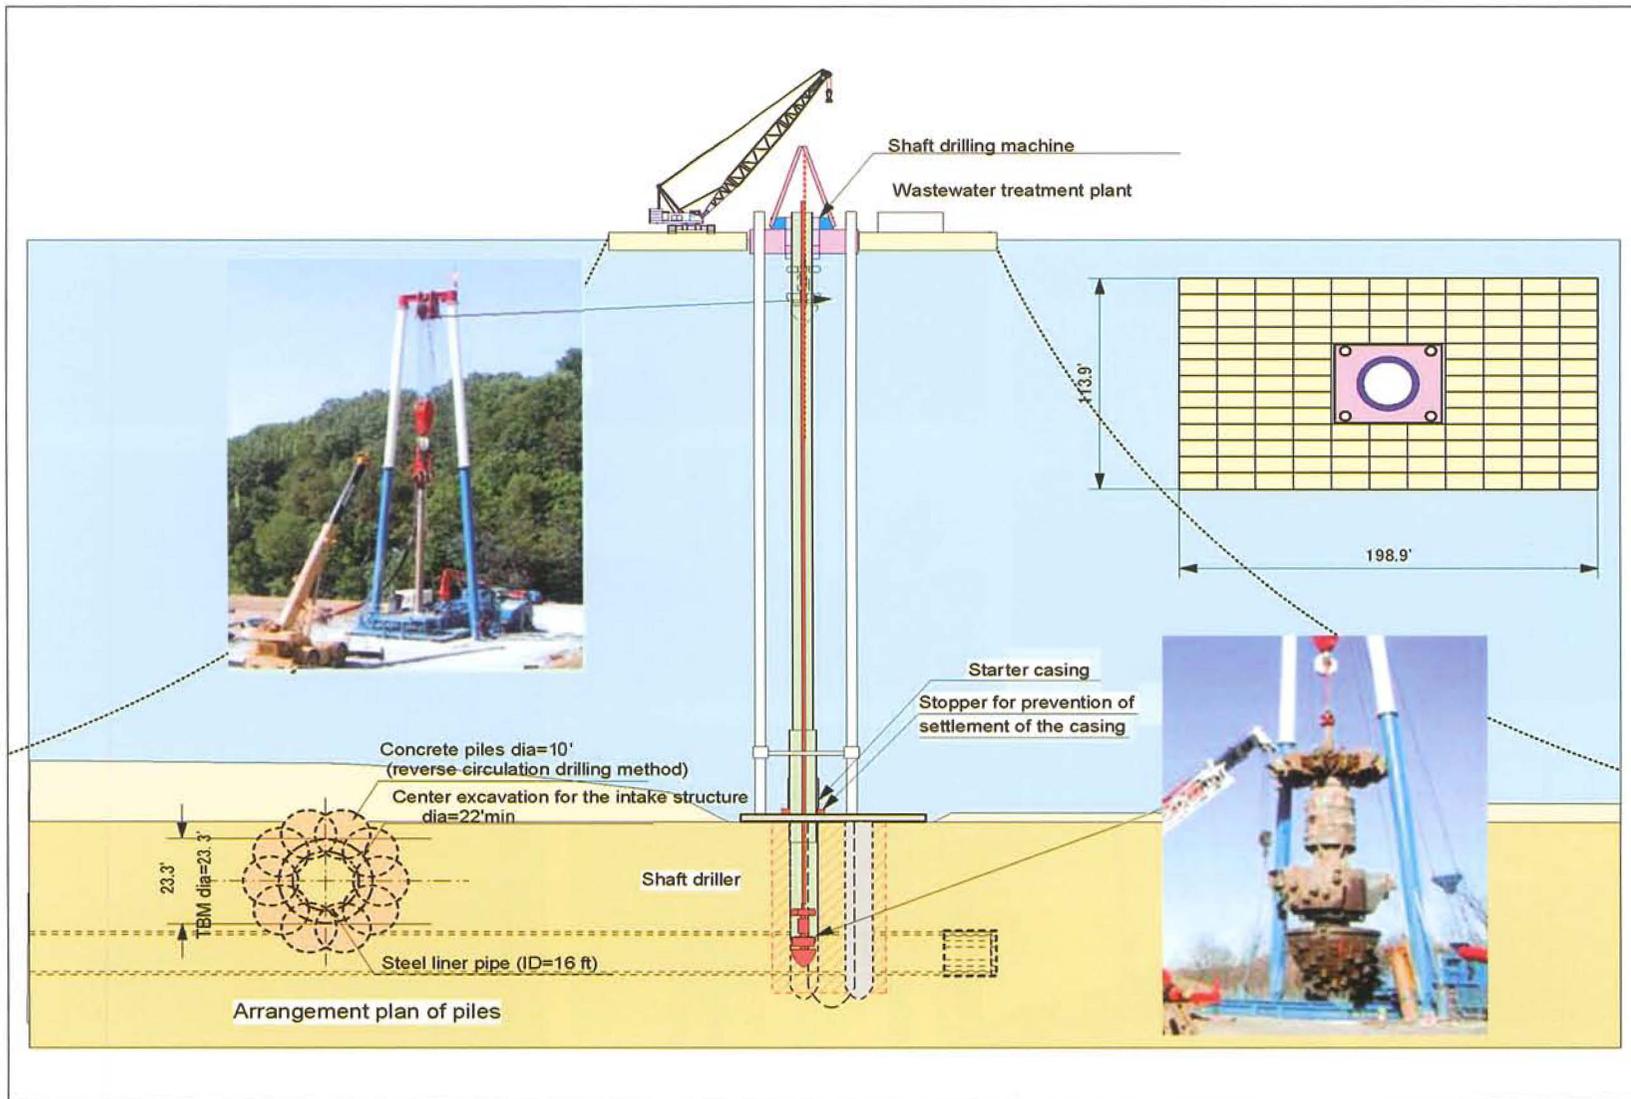
FIGURE 4.5 One excavation option considered by the SNWA involved placing an interlocking circle of secant piles, shown here.

- Drilled Shaft Option (Figures 4.5 and 4.6):  
Excavation of medium-to-large diameter (3 ft [0.9 m] to 10 ft [3 m]) secant piles using a down-the-hole hammer in a rectangular pattern, then breaking the rock between the shafts using chisels or explosives. A template frame was planned to maintain the pattern of drilling activity.

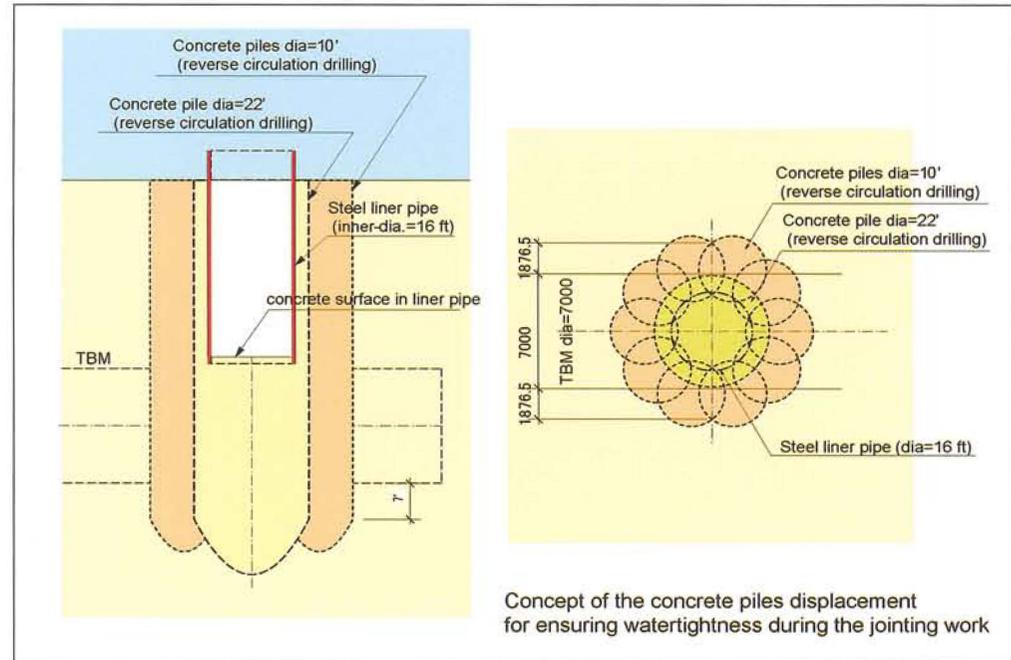
FIGURE 4.6 Once the secant piles were set, a shaft was to be excavated and lined with steel to allow intake riser placement.

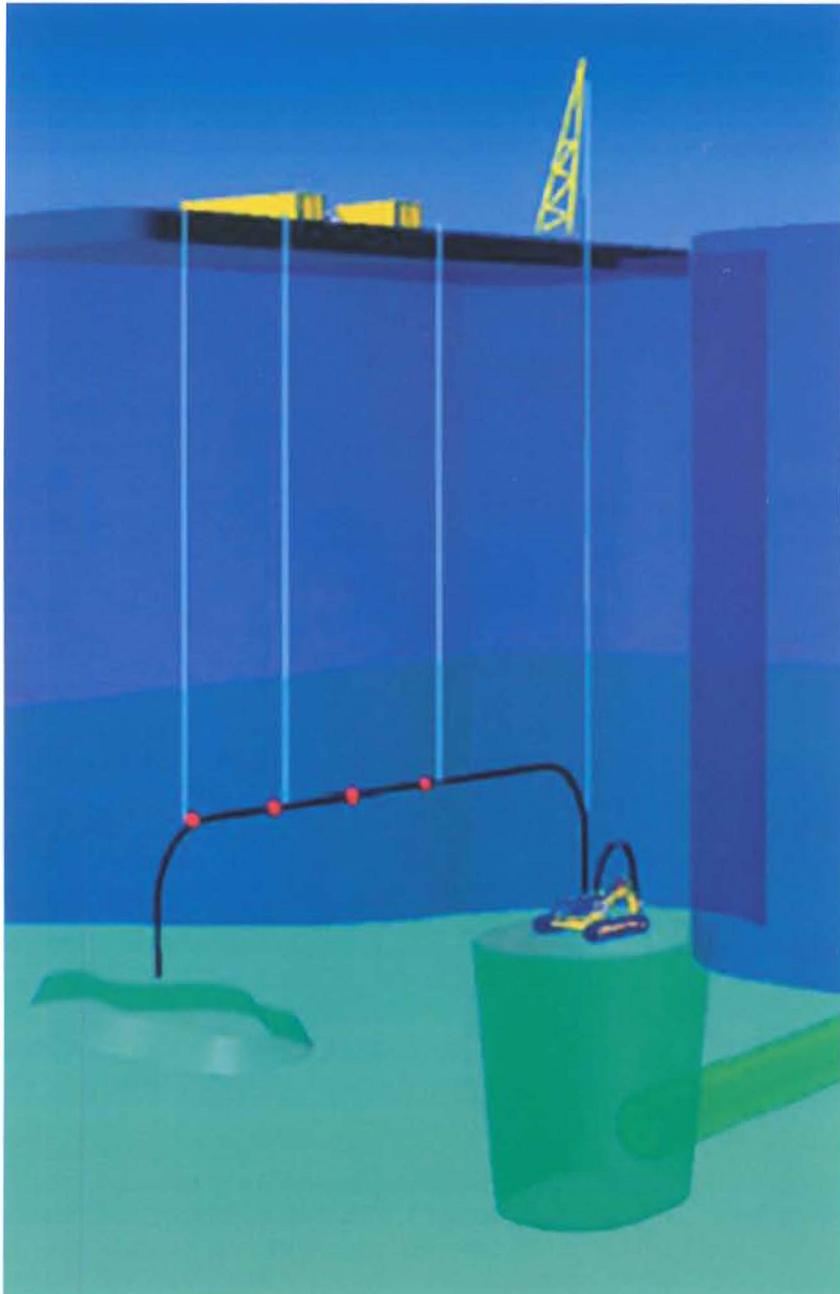
FIGURE 4.7 Another excavation method considered used virtual reality techniques to control a first-of-its-kind excavator equipped with a crusher head and airlift system to transport excavated material.

- Remote Operated Equipment Option (Figures 4.7 and 4.8): Excavate using a prototype heavy hydraulic excavator equipped with a crusher head.
- Drill and Blast Option (Figure 4.9): Holes, drilled from a barge using a hole template, loaded with explosives. Resulting debris removed by crane and clamshell bucket.
- Shaped Charges Option: Rock excavation using shaped charges.

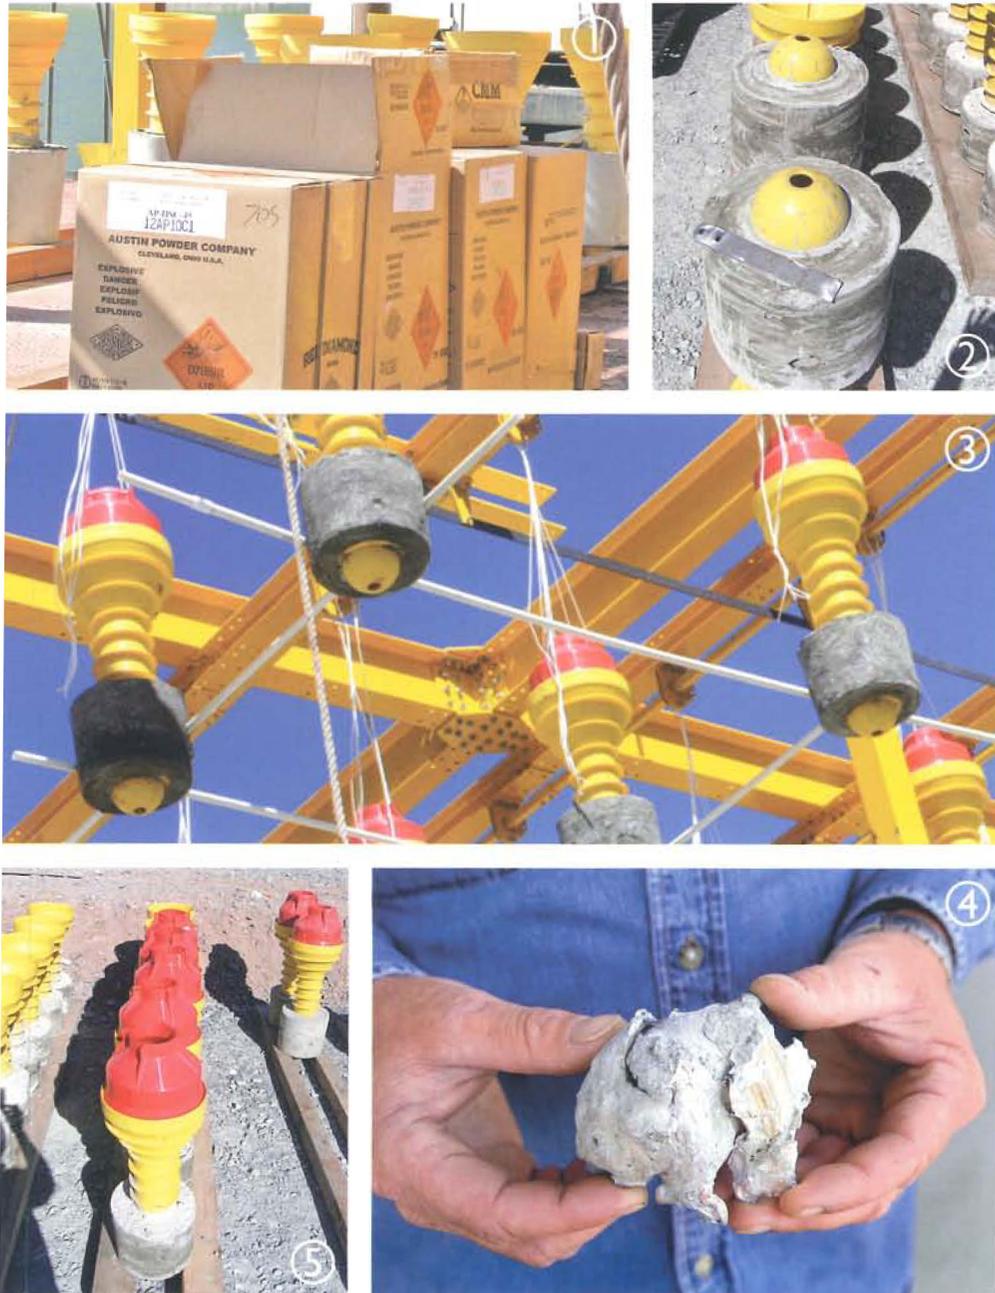
FIGURE 4.10 Designed specifically for the Lake Mead Intake No 3 project, the shaped charges are composed of: ① upper shell, ② liner, ③ bottom shell, and ④ plug.

Nitrex supplied the shaped-charge housings, including the upper shells, bottom shells, plug, and all plastic material. Nitrex also supplied the aluminum liners for the charges from which the slug developed during detonation. The top part of the canister (items 1, 2, and 4 shown in Figure 4.10) was shipped directly to Austin Powder Company of Cleveland, Ohio. Austin filled each charge with about 20 lb [9 kg] of composition B explosive, which was placed directly

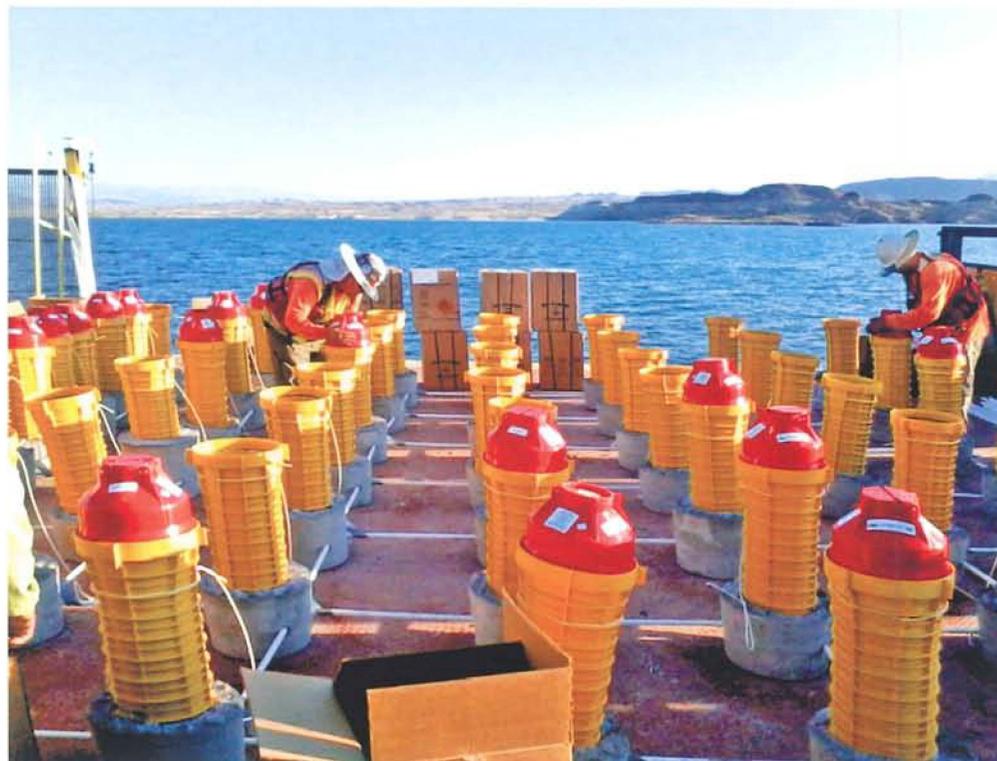
FIGURE 4.11 Shaped charges. ① Composition B explosive. ② Concrete ballast. ③ Charges arranged on a test frame. ④ Part of a slug following detonation. ⑤ Shaped charge shells.

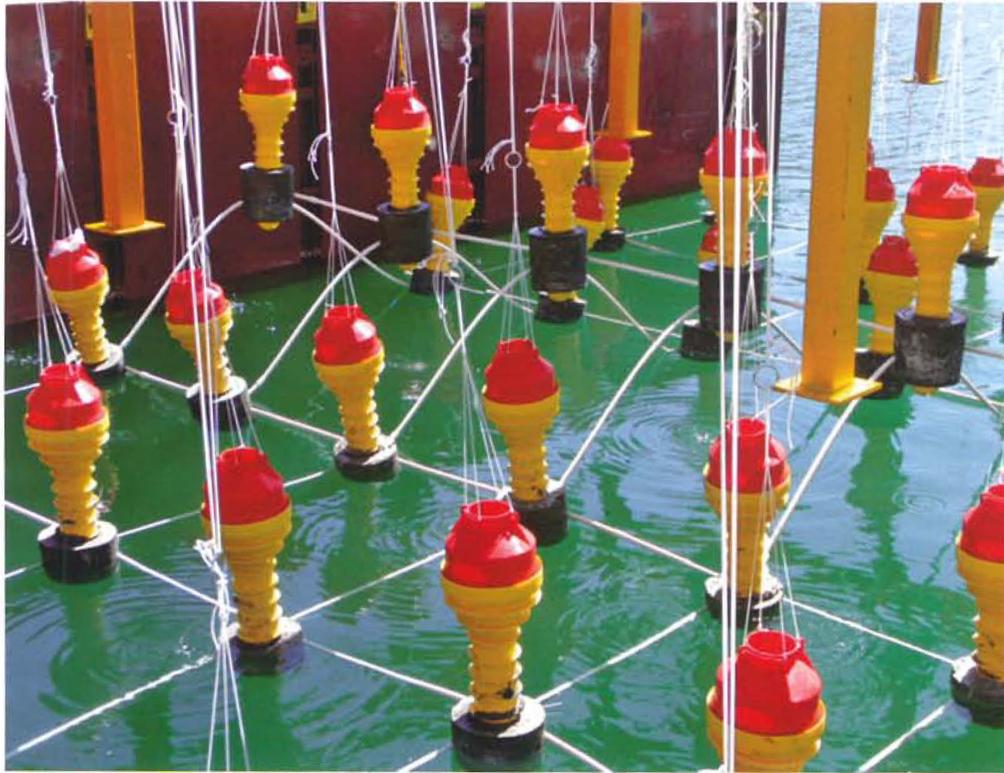
FIGURE 4.12 Shaped charges being prepared on the blasting barge.

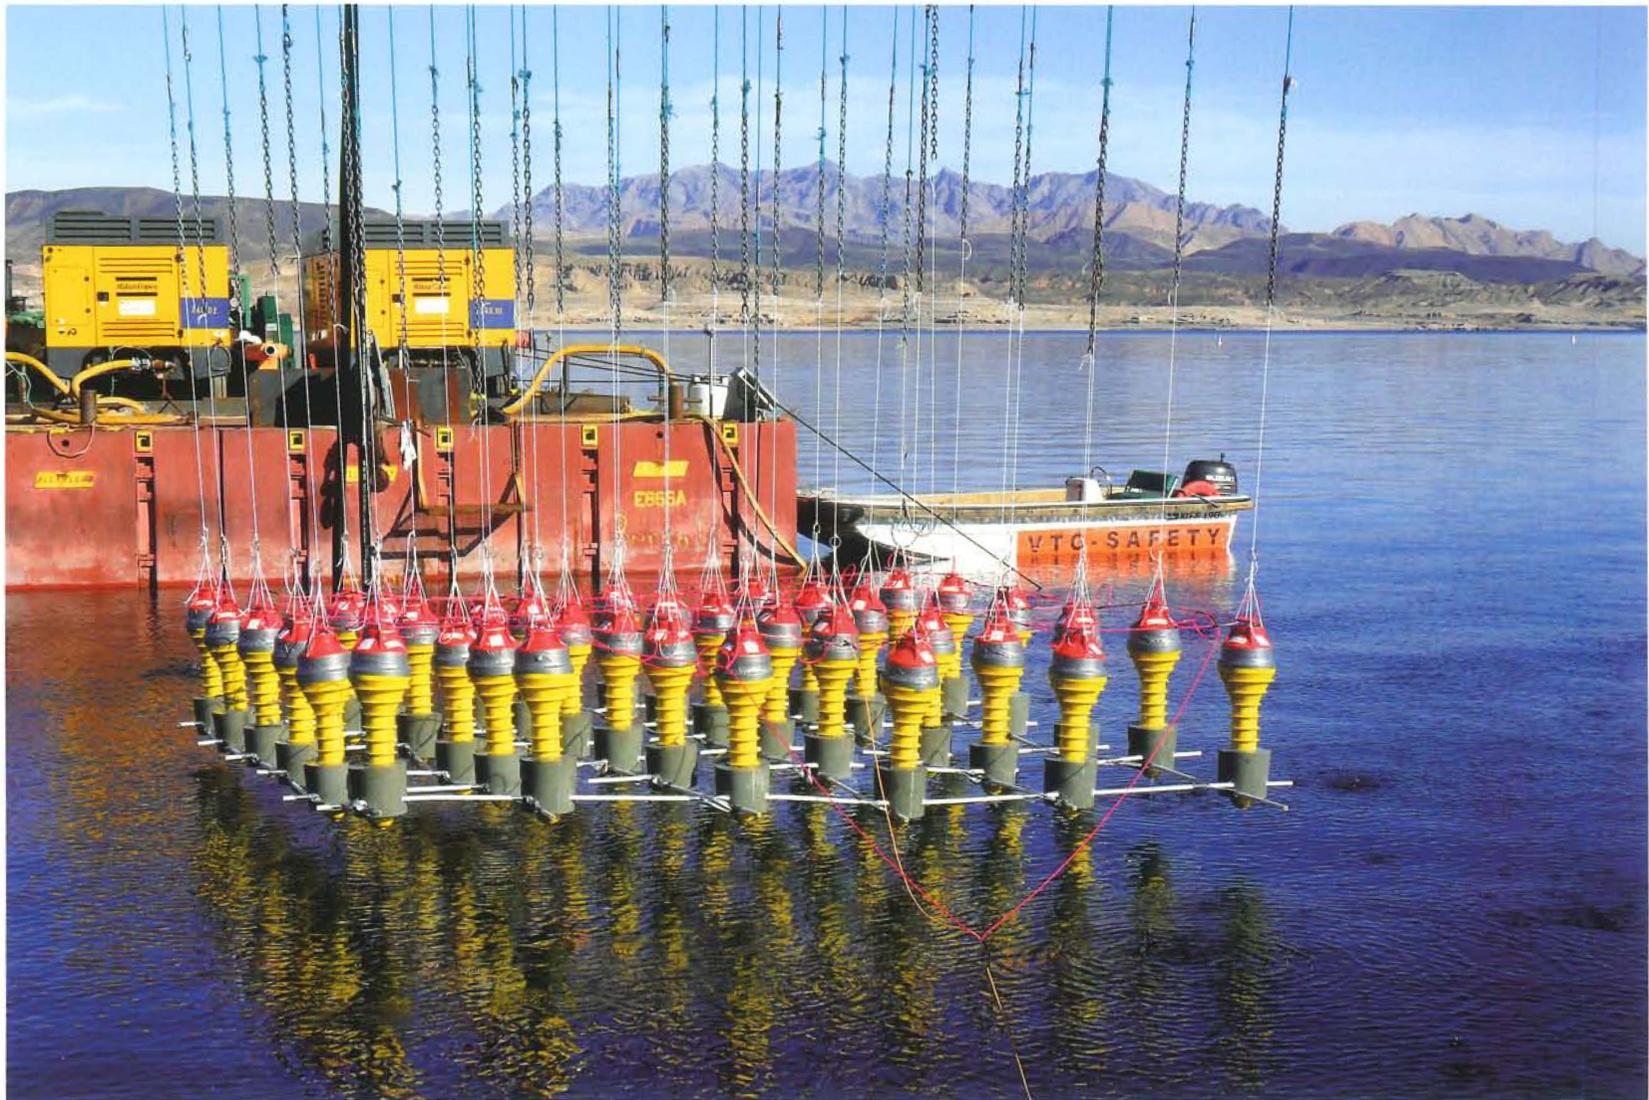
FIGURE 4.13 Testing the flexibility of the PVC-pipe grid, which kept the charges at proper spacing.

a grid. This pipe grid maintained the effective area offset intended for the charges and allowed the charges to follow the profile of the bottom of the excavation (Figure 4.13).

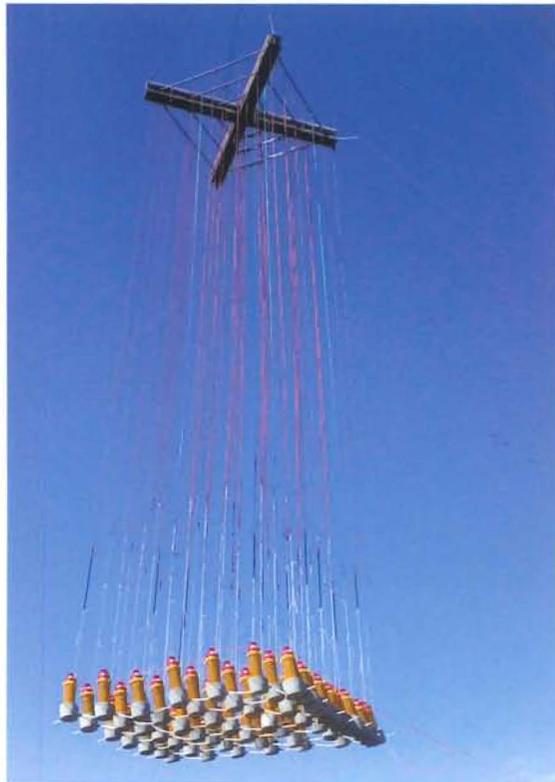
FIGURE 4.14 Lowering a field of shaped charges to the excavation site.

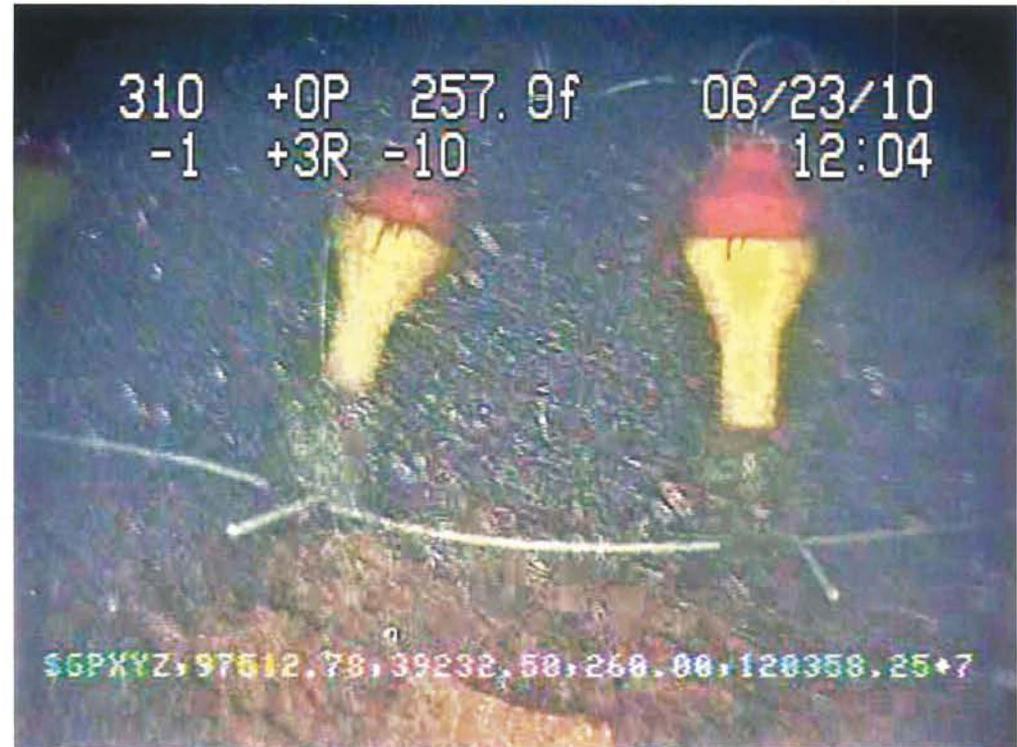
FIGURE 4.15 Each charge was suspended with two ropes: The lower was destroyed in the blast, while the upper could be reused.

Each shaped charge was hung from the steel frame using a ½ in. [13 mm] nylon rope about 49 ft [15 m] connected to a tippet of thin nylon rope tied directly to the shaped charge. After each blast, the destroyed tippet was replaced, and the ½ in. [13 mm] nylon rope was reused for setting the next round of charges (Figure 4.15). The booster and the detonating cord were connected to each charge, and another long piece of detonating cord was connected to a shock tube detonator. The shock tube reached the crane barge and was set off from the deck of the barge.

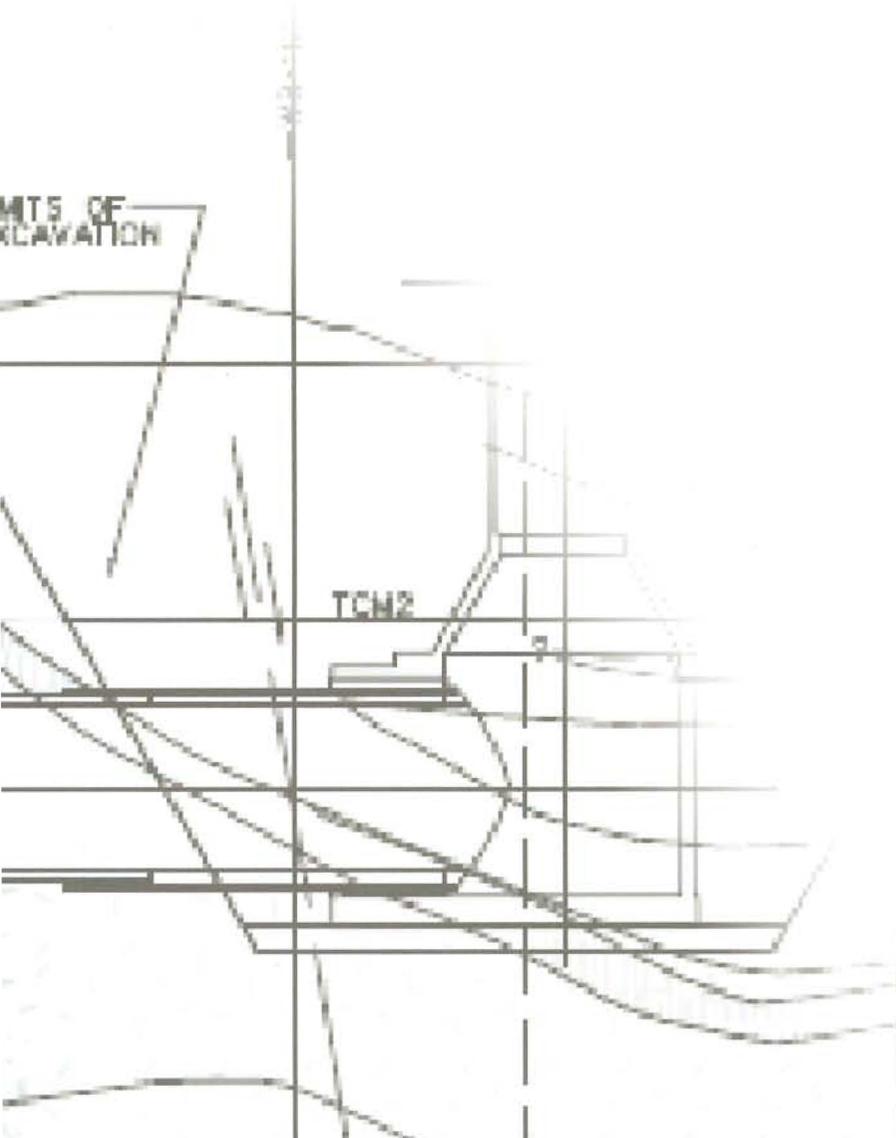
FIGURE 4.20 Detail from VTC's drawing M-988, "Excavation Cross Sections With Structure and Tunnel." The surveyed bathymetry (green and black lines) were generated periodically to monitor progress.

As the excavation progressed, it was necessary to check the amount of material actually been being removed. This was done with the use of a multibeam sonar system manufactured by Kongsberg of Norway. This equipment was operated by Nitrex and AUS. The multibeam sonar system was mounted to a dedicated vessel and used approximately once or twice a week depending on progress. It provided points in X, Y, and Z format, which allowed cut and fill volumes to be calculated based on the difference between the pre-project survey and the most recent survey. The sections from VTC's drawing M-988 show the progress of the excavation (Figure 4.20).
